### **SILVER SPRINGS APPLICATION ARTICLE**

#### **REMOTE SUPERVISORY CONTROL APPLICATION**

SILVER SPRINGS WATER SYSTEM CONTROL DIAGRAM

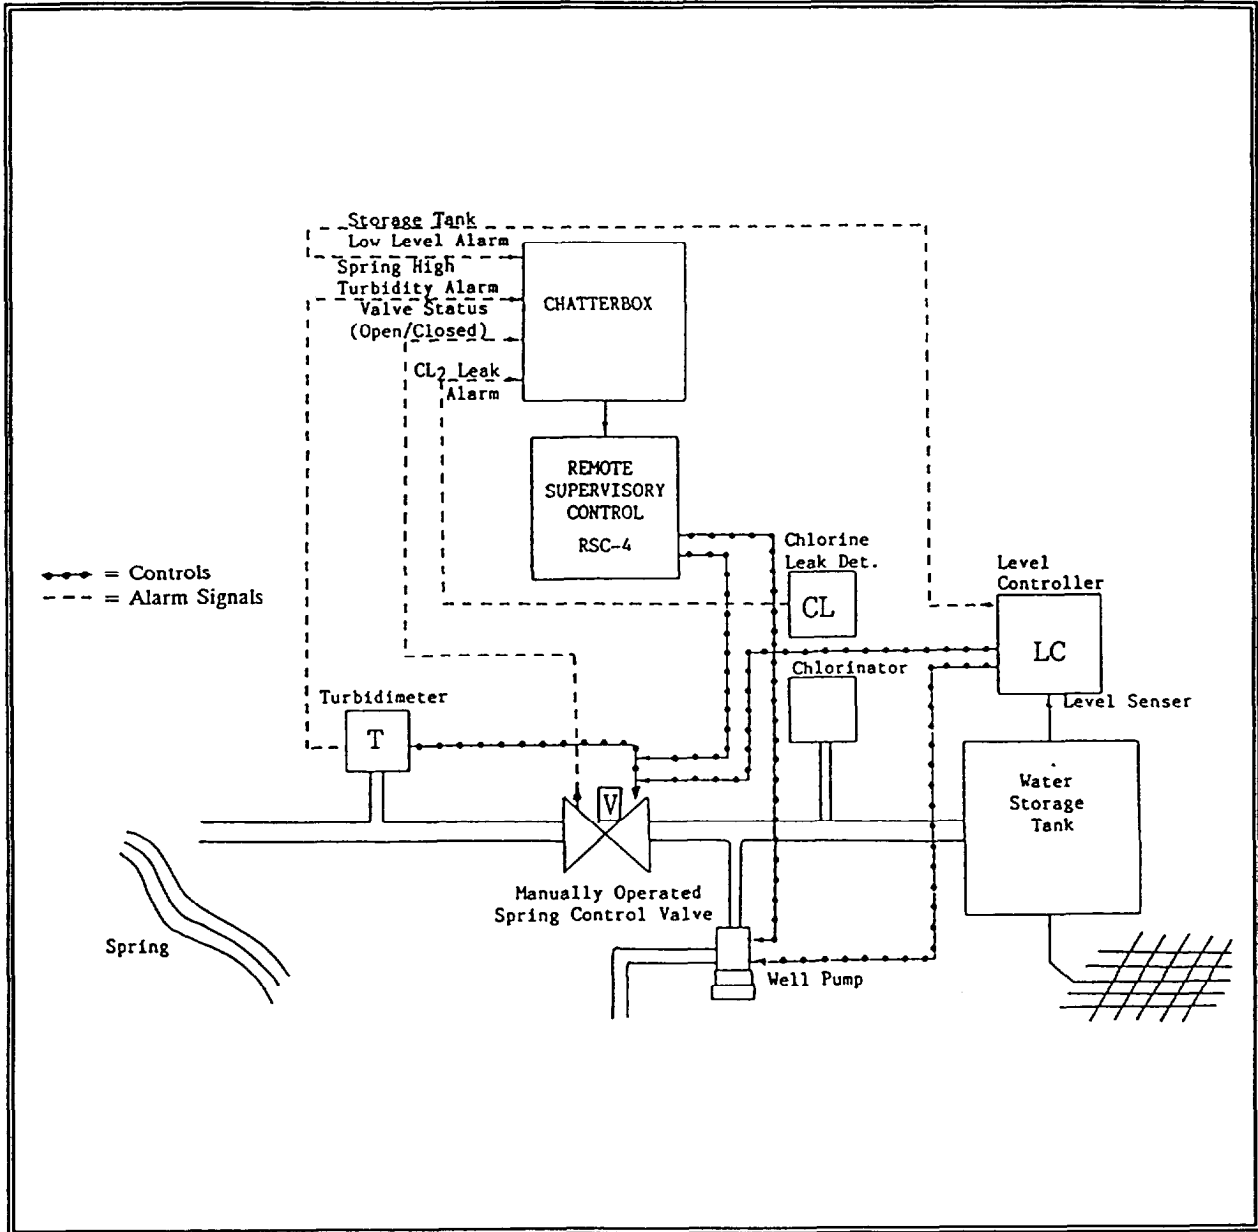
Referring to the diagram, the Chatterbox® system is programmed to monitor low storage tank level with a level controller [LC], high spring turbidity from a turbidimeter [T], spring valve open/close status [V], and chlorine leakage using a chlorine leak detector [CL]. The facility is normally unattended.

When the water from the spring is too turbid, the turbidimeter closes the spring valve and sends a high turbidity alarm to the Chatterbox®. The Chatterbox® then calls Lynn at home, at the office and on his portable radio telephone until it finds him. When Lynn receives the voice synthesized message he can decide if the water level in the storage tank should be raised by turning on the well pump, which he can do using touch tone commands on his phone.

In the event of a low tank level alarm, he checks the status of the manually operated spring control valve. If it is already open he

can then turn on the well pump to augment the flow of water to the storage tank.
